Failure Analysis of a steam condensate pipeline in 2nd refinery of South Pars Gas Complex

In this work, we were studied a failure in a steam condensate pipeline of a gaseous refinery in South Pars region in January and December 2013. Failure analysis was conducted on pipeline (16 inches) via visual/mechanical/corrosion inspection and operating history. Visual inspections showed rupture on pipeline. More inspections showed the rupture is caused because of corrosion inside pipeline. The study of mechanical aspect was demonstrated the vibration in pipeline. The morphology of split pipeline at 6 o'clock showed synergy of Oxygen, dioxide carbon corrosions. As well as, cavitation caused other failure on tee of pipeline.

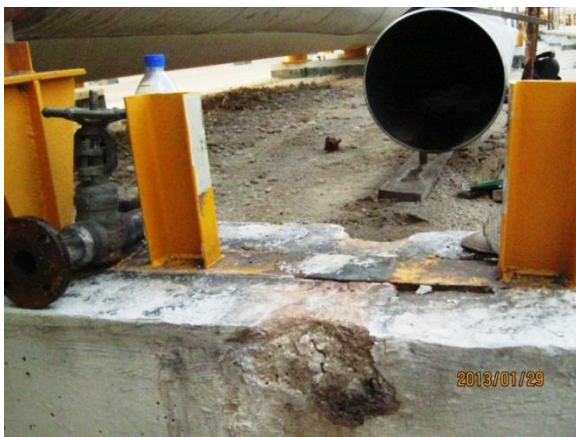
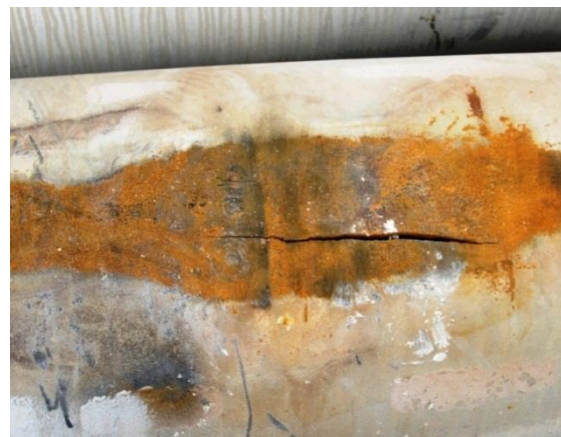
Failure of a pipeline (line no: 16"-CP-160-12101-B01-N) was reported in January 2013. Visual inspection showed a leakage on pipeline. A groove on pipeline was observed as well as, the concrete support was damaged. For more investigation, the pipeline was cut. Figure 1 showed a rupture on the pipeline and damaged support after cutting of the pipeline.

The pipeline supports were located in improper conditions. The piping should be worked according to ASME B31.3 (pipe support criteria for the above ground piping). The support of pipe should be able to absorb the loads arisen from fluid vibrations. Unfortunately, pipeline supports were not properly performed. As well as, improper function of the expansion loops led to move the load to the

Figure1. Damaged support (left) and rupture on pipeline at 6 o' clock position (right)

pipelines. The increase or the decrease in flow velocity can cause pressure vibrations. The changes of flow velocity can be caused by sudden closing of valves, start up and stop of pumps, control process, and pump power failure. As well as, the loads of steady state conditions, the pipeline, and affiliated equipment have a heavy dynamic loading. Pressure changes lead to vibration in pipelines. Vibration phenomenon in pipeline is called Hammering. Due to hammering phenomenon, many parts of the pipeline were severely damaged. Also, adjacent pipelines were affected by hammering phenomenon. In order to remove hammering effect, the installation of fix support (anchor type) is necessary. Fix supports (Anchor type) restrict pipeline expansion in the expansion loop. As well as, they remove longitudinal displacements. So, the installation of fix support leads to high efficiency of expansion loops.

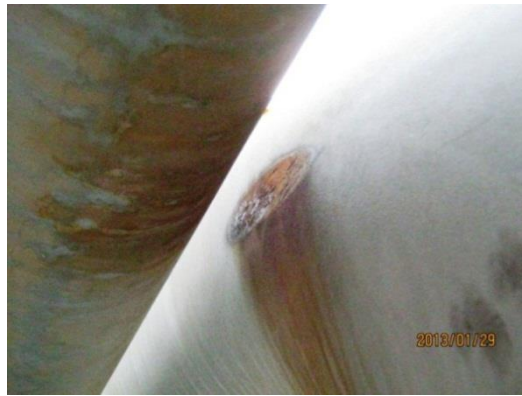
The concrete supports of pipeline were damaged. The pipeline was rubbed on adjacent pipeline and support. Figure 2 shows the damage on pipeline because of erosion on adjacent pipeline.

Figure2. The erosion of pipeline 16 inches on adjacent pipeline

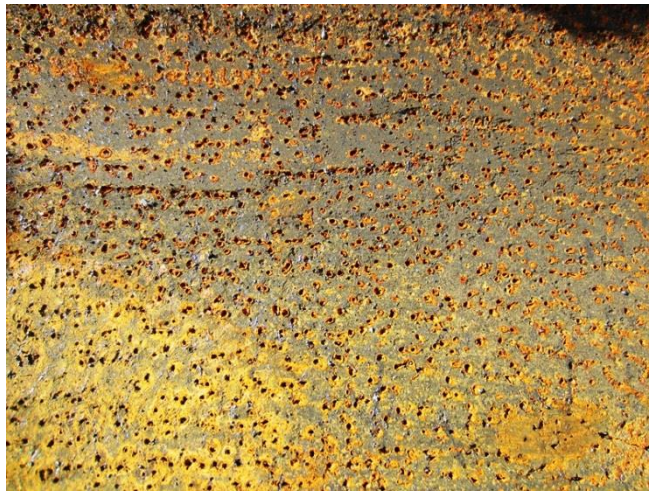
The damaged section of the pipeline was selected for corrosion investigation. The pipeline was split and its inner surface was carefully studied. The inner surface of pipeline is shown in Figure 3. On The inner surface was observed yellowish and greyish-black deposits. Some points were covered with shallow pits over the surfaces. General thinning and extensive pitting were found at 6 O'clock position. Thickness Measurement of pipeline wall was done using ultrasonic thickness measurement (USTM). The reduced thickness was 2.5 mm. Figure 4 shows the groove on the surface of pipeline.

Figure3. The inner surface of pipeline

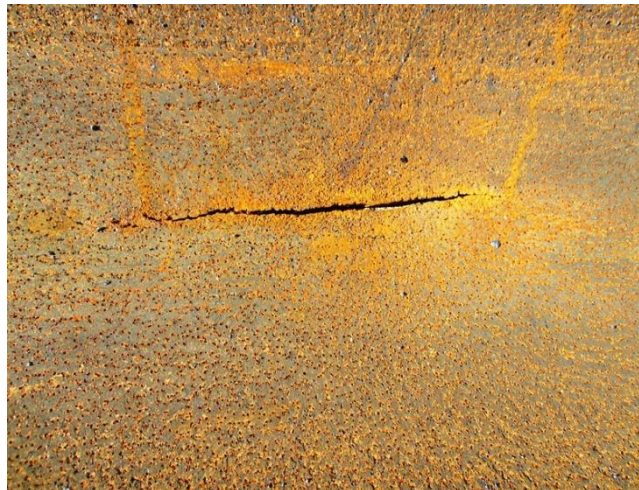
Figure4. Groove on the surface of pipeline

Figure 4 showed a grooving morphology. Grooving corrosion in steam and condensate streams is caused by synergy of two or more corrosion mechanism such as carbon dioxide and oxygen. Therefore, the groove on pipeline was caused by CO_2 and O_2 attacks.

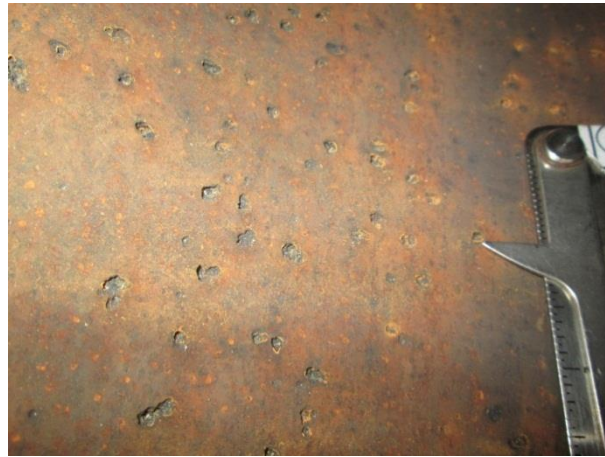
Figure6. The pitting on inner surface of straight stream of pipeline

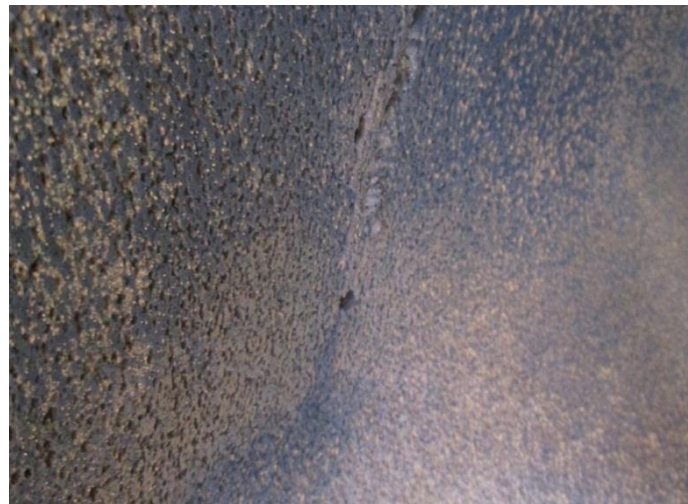
In order to investigate oxygen attack, the quality of feed water of boiler was measured. Figure5 shows the concentration of oxygen in boiler feed water. The results show that oxygen concentration is allowable according to Maximum allowable concentration of oxygen (7 ppb). For more investigation, some points inside steam condensate system should be measured for studying of oxygen concentration. Unfortunately, any data were recorded as daily for monitoring oxygen in the polluted steam condensate. Therefore, we cannot use experimental data for analysis. The concentration of oxygen should be sampled on site. Also the sample should be cooled for measurement. Other failure of this pipeline was reported in December 2013. Two points were failed. One point was on straight stream of pipeline and other was a tee. We were investigated morphology of corrosion after cutting of pipeline. Figure 6 shows the pitting on inner surface of straight stream of pipeline. As seen from this figure, the morphology of pitting looks likes oxygen attack. As well as, yellowish deposits demonstrate this case. Figure7 shows inner surface of tee. As seen from this figure, morphology of corrosion is similar to cavitation. As well as, this morphology in tee section was occurred and in service time, pipeline had vibration. Therefore, it is clear that cavitation phenomena have significant effect on this failure.

Figure 7. Inner surface of tee
