Microstructural Insights and Composition Analysis of a Fractured Brass Alloy of Unknown Composition Using Advanced Characterization Techniques

Abstract

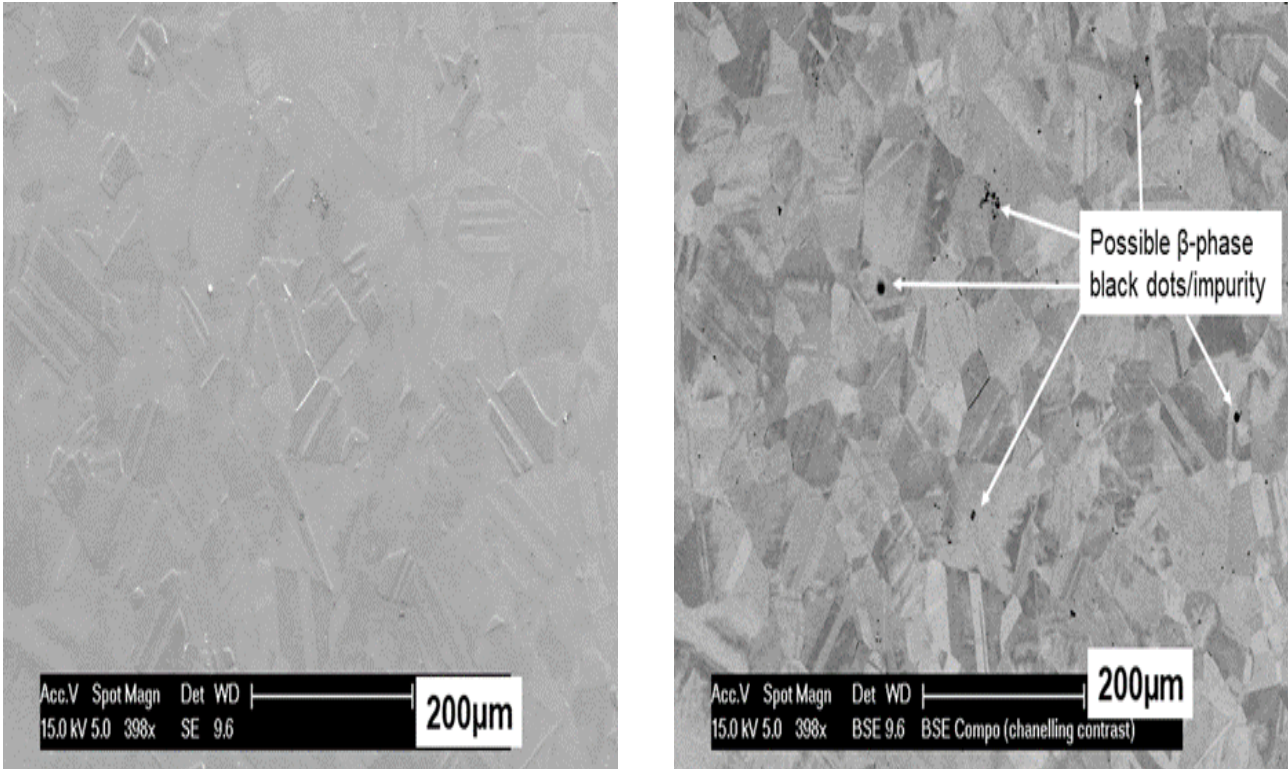
Figure 1(a) illustrates a Secondary Electron (SE) image of a polished brass sample that has revealed certain significant features like the size of grains, orientation, shapes, types, and grains. The equiaxed structure of the grain in the sample shows uniform solidification of the alloy during processing, with the varied grain sizes in a range of 10 to 80 µm in diameter. In the figure, a large grain size is denoted by the fact that re-growth occurred in some of the crystals, and this increased with an increase in the annealing time. The increase in ductility in this case is also due to the annealing treatment. Figure 1(b) is a BSE compositional contrast with the mapping of a solid-solid solution specimen; bright areas

Clear geometrical grains structures and their location indicate the likely occurrence of single α-phase brass. As of the grain orientation shown in the image, its random location shows an isotropic property of this solid-solid solution. The randomly formed darker spots could behave as a nucleation site for the initial formation of the β-phase or impurities. Straight-sided bands running across grains in **Error! Reference source not found.**(a) shows annealing twinning. The reason for twinning can be attributed to the fact that the brass alloy sample underwent some annealing work as suggested by [2] and giving idea about material processing history. During annealing, the atoms in the metal rearrange themselves into a more stable and organized structure, which can lead to the formation of twinned crystal structures in some materials for instance materials of high stacking fault energy. Twinning is basically the different orientation of the crystal structures of same atomic arrangement within the same grain. Twinning can be desirable and predictable, and it can affect mechanical properties in some cases it can be a problem, as it can lead to cracking and other forms of failure in metals [1].

Figure 3.1. (a) Secondary Electron image of polished brass sample, (b) Backscattered Electron (BSE) image of polished specimen.

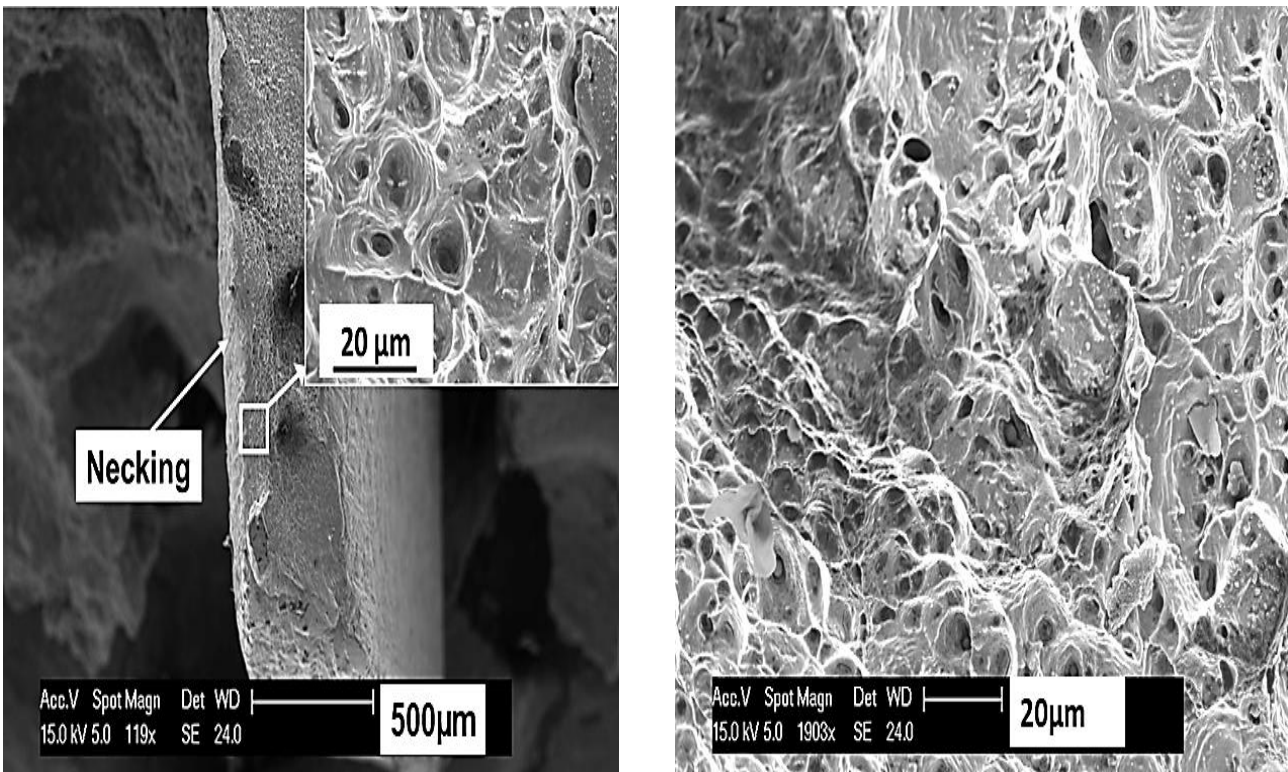
For fractography analysis, the fractured sample's images by Secondary Electron (SE) is presented in Figure 2. The fractographs in Figure 2(a-b) are taken on the plane perpendicular to the applied load/stress. It is essential to mention that the sample is tilted about 30° to the vertical axis of the page. Tilting specimen is done because fractures often occur at an angle to the surface which make it difficult to get a clear view of the fractured surface topography and morphology [2]. In **Error! Reference source not found.**(a) at 500 µm scale the specimen is tilted and it shows graphical illustration of fractured surface. In this image at lower magnification the edges are curved towards the center of the specimen which shows necking during fracture process. In the middle of the specimen at higher magnification in **Error! Reference source not found.**(b) shows many spherical dimples of different sizes which shows that the material underwent ductile fracture, indicating that it deformed plastically before failing. The presence of different sized dimples suggests that there were variations in the local stress and strain conditions during the deformation process. Steps involved in the fracture process is explained later and graphically illustrated in **Error! Reference source not found.**.

Image in **Error! Reference source not found.** at right bottom shows that necking of the specimen occurred before fracture which is sign of the ductile fracture in ductile materials. Furthermore, ductile fracture is a typical surface contour of the obtained sample. It is called a cup-and-cone fracture because one of the connecting surfaces is cup shaped and the other is a cone shape [3]. At high enlargement, it can be seen that there are many dimples on surface, which are characteristics failure features due to uniaxial tensile failure [3]. The resulting dimples on the fracture surface are the direct result of the micro-voids that form during this process. Each dimple corresponds to half of void created in the fracture process. The presence of these dimples is a clear indication that the material underwent significant plastic deformation prior to fracture, and therefore it can be identified as a ductile fracture. This type of fracture is often seen in materials that can undergo significant deformation before failure, such as metals and certain polymers.

Figure 3.2. (a) SE SEM image of fractured specimen with magnified inset view, (b) SE SEM image of fractured brass sample

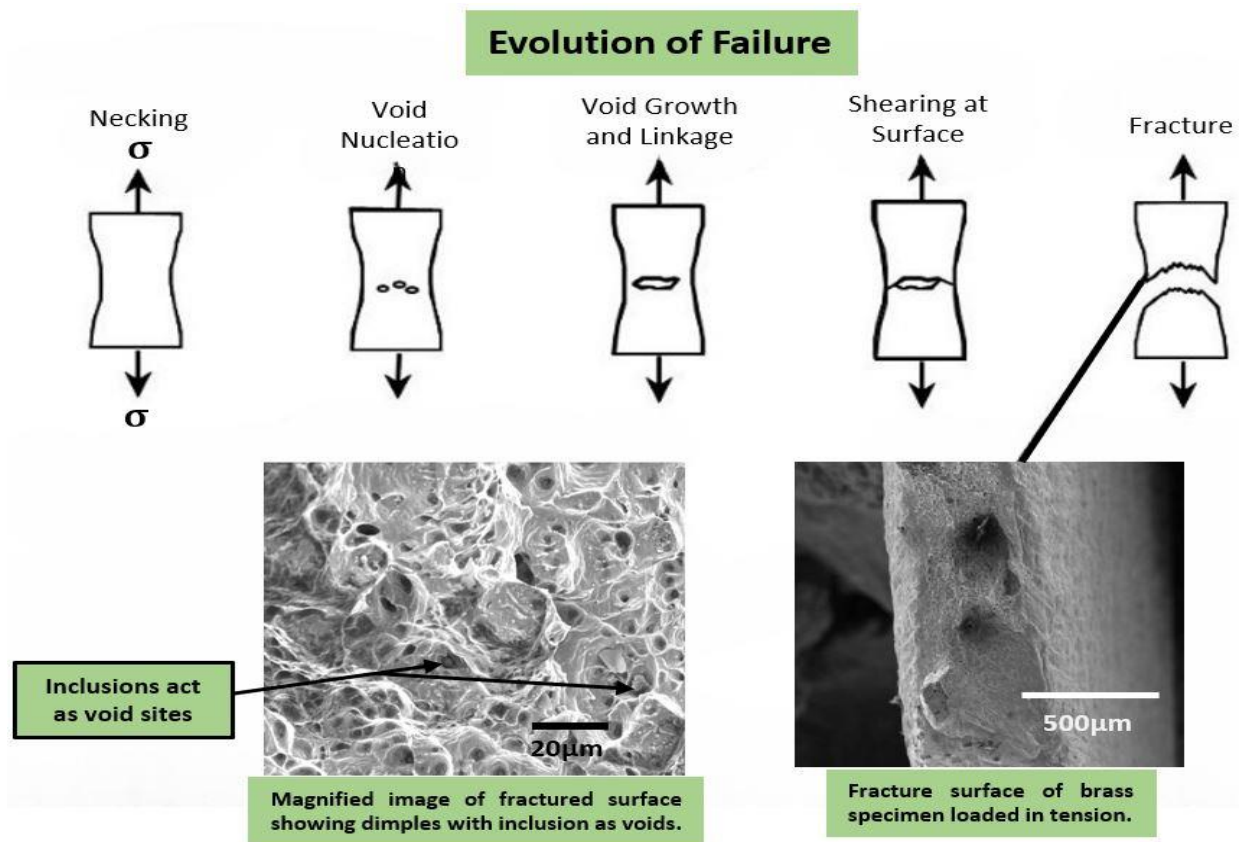
Fracture process is a sequence of events that occurs in material when it underwent failure due to an external load or stress. **Error! Reference source not found.** shows the complete fracture process under the influence of an applied tensile load. It shows that necking is the first step starts under the applied stress and is followed by small cavities and micro-voids in the interior. When a material undergoes tensile deformation, the atomic bonds between neighboring atoms are stretched, causing localized areas of strain. As the strain

in these regions reaches a critical level, micro-voids start to form, resulting in small areas of localized deformation within the material. These micro-voids then grow and coalesce to form larger voids, as observed in Figure 3 (void growth and linkage) as elliptical crack is formed that is perpendicular to the applied stress. Cracks propagation propels due to further merging of cavities and micro-voids. Finally, the rapid propagation of cracks around the outer surface completes the fracture process[3]. The inset in the **Error! Reference source not found.** bottom left shows the magnified image of the cracked surface revealing the topographical features at micro-level gives details about the type of fracture.

Figure 3.3. Crack propagation mechanism started from cracking following a series of steps before ending on fracture/failure.

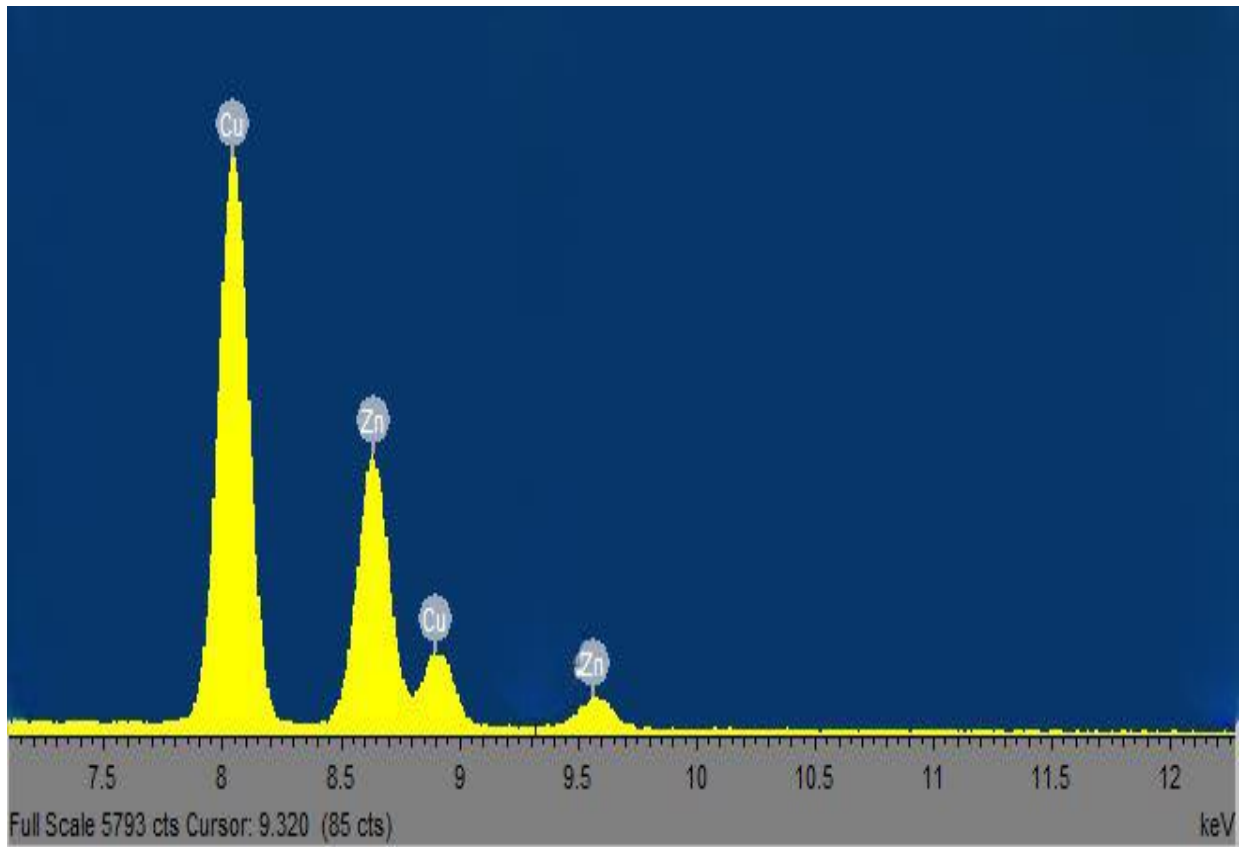
Error! Reference source not found. illustrates the quantitative analysis and chemical composition of the unknown brass alloy sample. Based on the above Equation (1) concentration of Cu and Zn (C_{Zn} and C_{Cu}) in the sample was calculated as shown in the **Error! Reference source not found.**. Initial values obtained for Cu and Zn were 61.69 wt% and 36.42 wt%, respectively. These correspond to atomic

percentages of 63.55 at% for Cu and 36.45 at% for Zn. After normalisation, the values were found to be 62.88 wt% for Cu and 37.12 wt% for Zn, corresponding to atomic percentages of 63.56 at% for Cu and 36.44 at% for Zn. The certified nominal composition of the sample was 63 wt% Cu and 37 wt% Zn, or 63.65 at% Cu and 36.35 at% Zn.

**Figure 3.4.** Shows EDS spectrum of point analysis from brass sample.

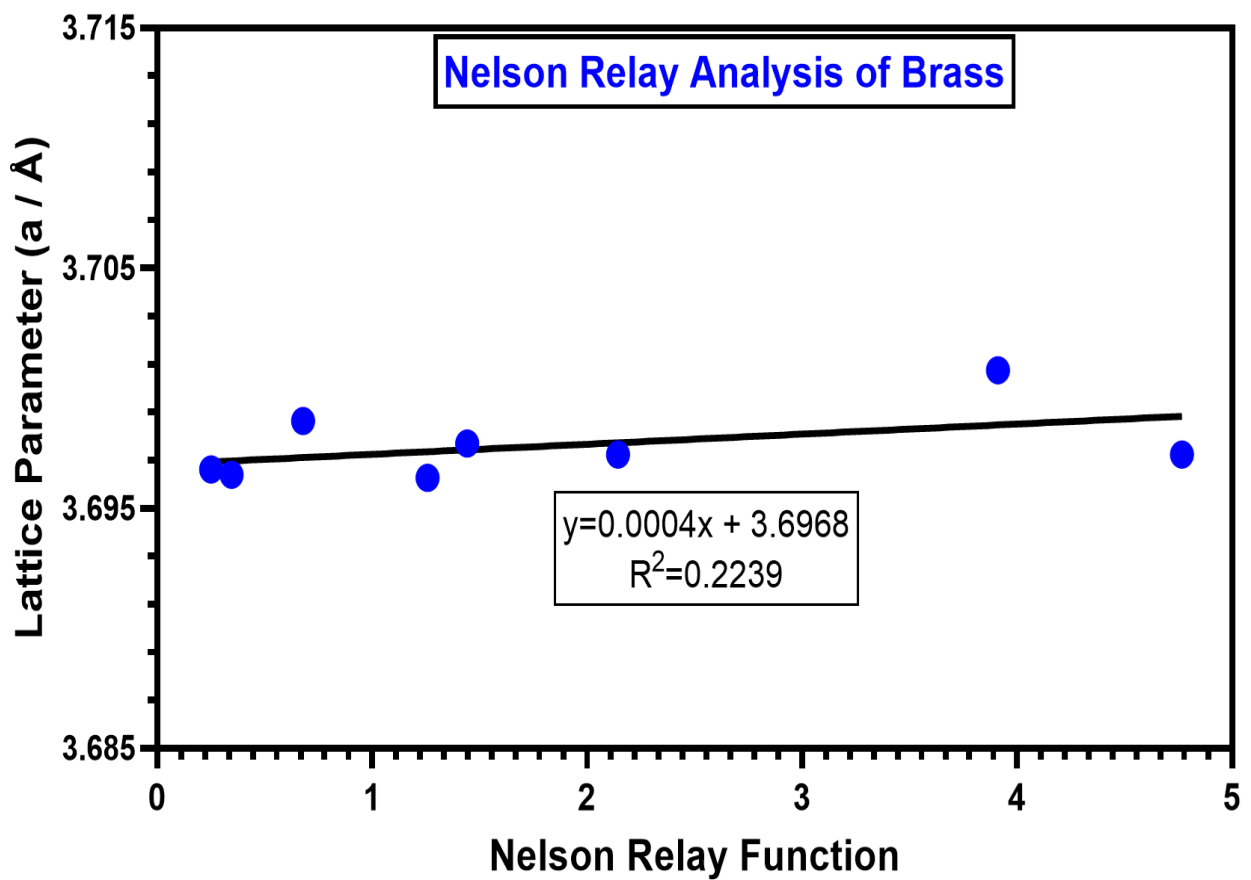
Figure 3.5. Determination of the lattice parameter by reduction against the Nelson-Riley function.

This co-relation accurately predicts the precision of a given measurement. In this research work, we utilized the indexed peaks and calculated preliminary lattice parameter for each peak. To determine the lattice constant, we plot the calculated lattice parameter (a) values against the Nelson-Riley function as shown in **Error! Reference source not found.**. By constructing a linear regression analysis, we can determine the y-intercept, which corresponds to the point where the Nelson-Riley function, and consequently, the fractional change in lattice parameter ($\Delta a/a$), approaches zero. Based on this analysis lattice parameter for sample under observation found to be 3.69 Å. The relationship between the concentration of Zn in brass and Lattice parameter is shown in **Error! Reference source not found.**. Brass alloy of varying Zn concentration was made from 99.99 at% Cu and Zn casted and homogenized at 650 °C for finding lattice parameters. Lattice parameters of annealed brass alloy reported by Rao and Anantharaman (1963) in their interesting work done on Cu-solid solution. From this relationship in **Error! Reference source not found.** and using the lattice parameter obtained through N-R function composition of unknown brass alloy sample in this work was found to be 34.65756 at%. Concentration of Zn found through this method is 6.33 at% lower than the nominal composition. However, while using EDS for chemical analysis of same brass alloy Zn concentration was found to be 37.12 at% as opposed to 34.66 at% Zn while using XRD as chemical analysis tool. This discrepancy in results is because XRD is good in determining crystal structure of materials but is not a reliable tool for chemical analysis of the materials.

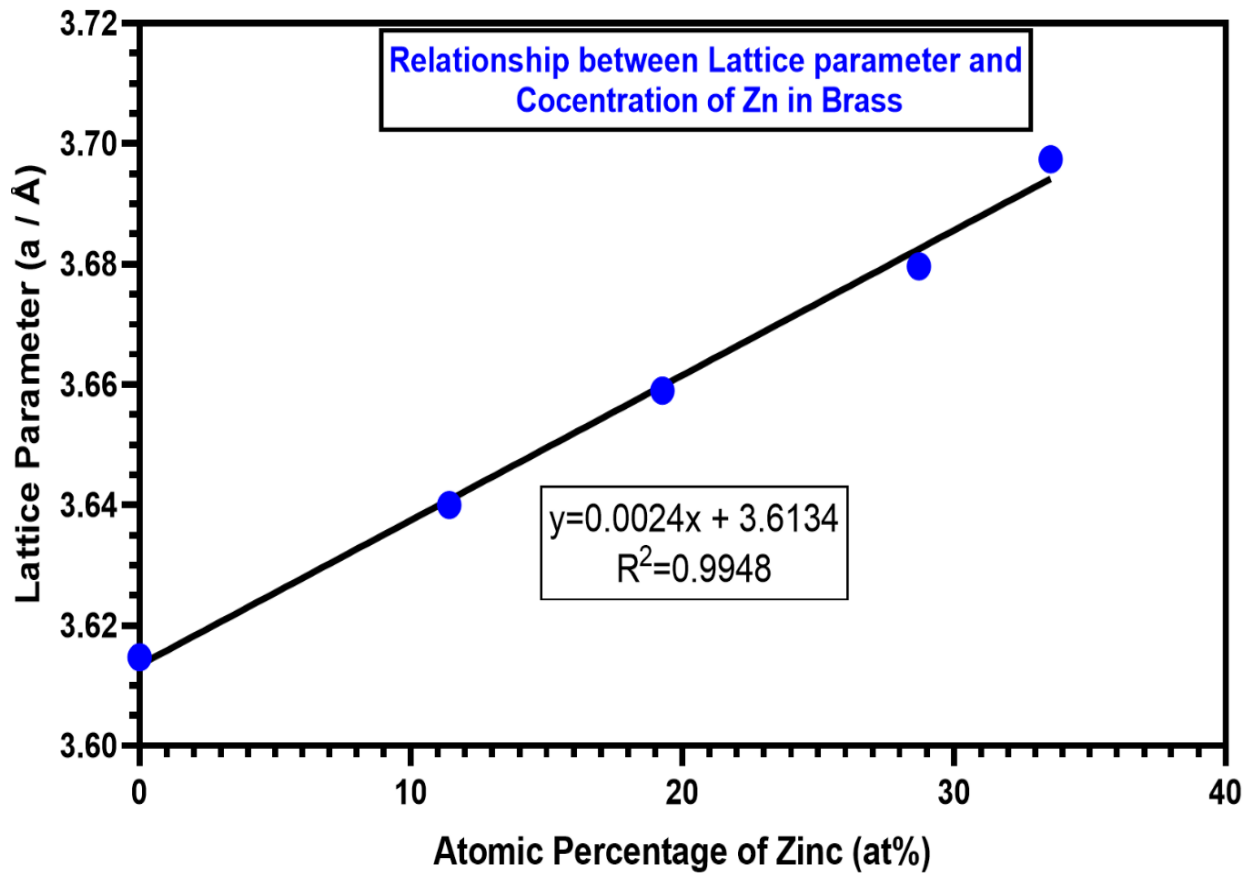
Figure 3.6. Relationship between lattice parameters and concentration of Zn in Cu-Zn alloy.

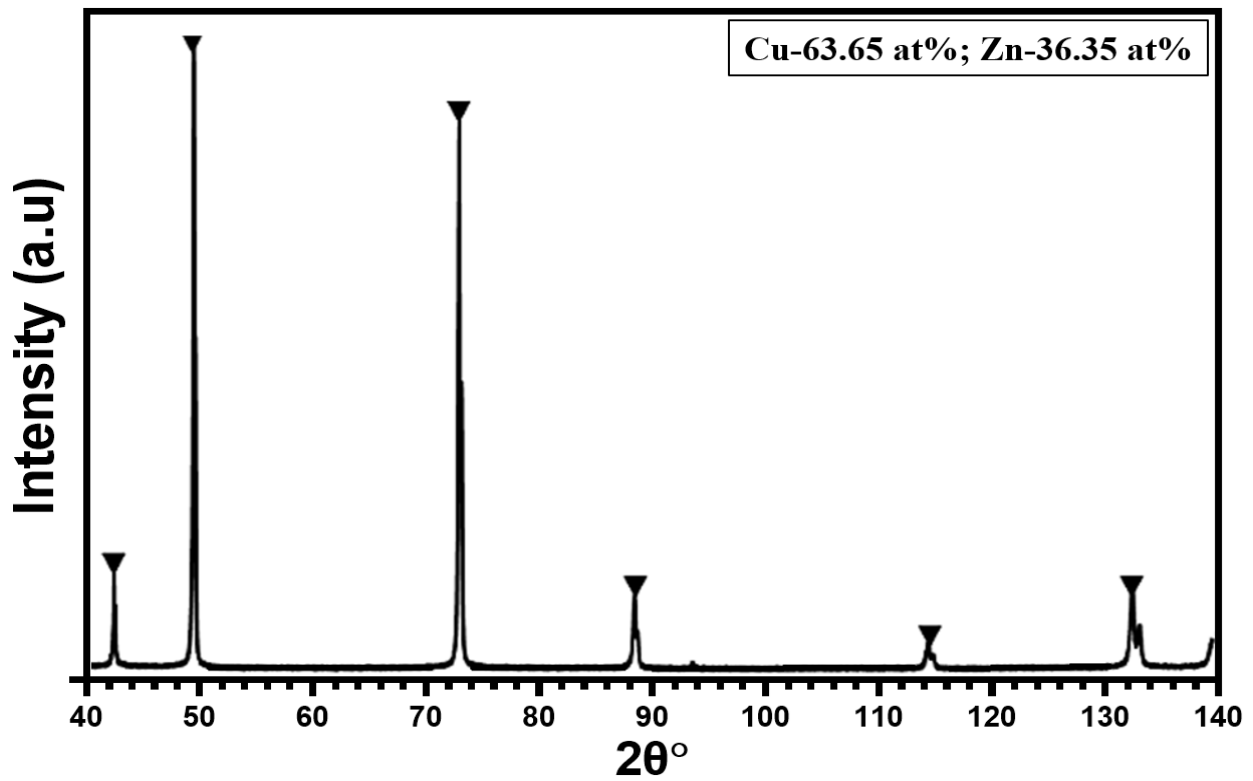
Figure 3.7. XRD scan of the brass sample of 63.65 at% Cu and 36.35 at% Zn.

XRD scan for the sample obtained analyzed for the structural analysis of the brass alloy sample (**Error! Reference source not found.**). The obtained spectrum exhibited α-phase with FCC crystal structure. However, from the analysis of the XRD scan no traces of β-phase found as opposed to the black spots in SEM images (Figure *3.1*). The reason of no detection of the β-phase may be its lower quantity (<5%) as XRD is less-sensitive to presence

of minor phases[8]. Here it can be argued that the plastic deformation and necking of the brass fractured sample observed in SEM analysis of the broken sample is due to the FCC crystal structure. As FCC lattice structure has more slip planes in its slip system than other cubic lattice structures.
