Failure Analysis of a steam condensate pipeline in 2nd refinery of South Pars Gas Complex

In this work, we were studied a failure in a steam condensate pipeline of a gaseous refinery in South Pars region in January and December 2013. Failure analysis was conducted on pipeline (16 inches) via visual/mechanical/corrosion inspection and operating history. Visual inspections showed rupture on pipeline. More inspections showed the rupture is caused because of corrosion inside pipeline. The study of mechanical aspect was demonstrated the vibration in pipeline. The morphology of split pipeline at 6 o'clock showed synergy of Oxygen, dioxide carbon corrosions. As well as, cavitation caused other failure on tee of pipeline.

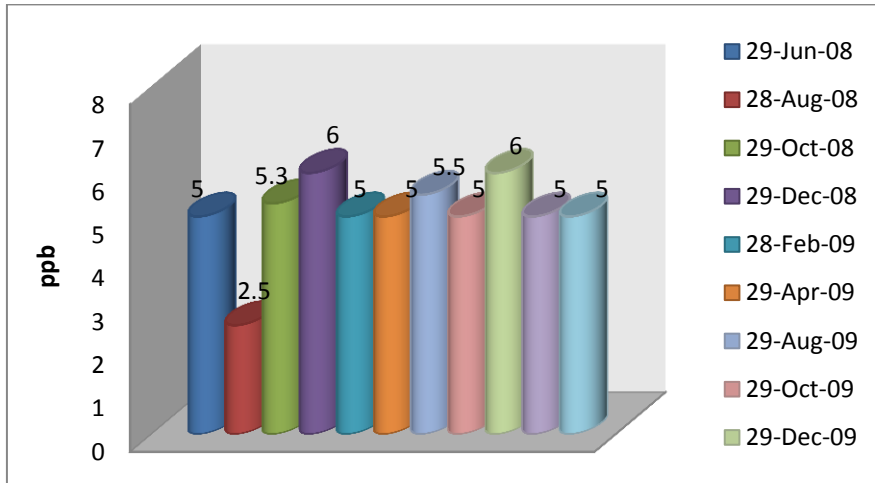
In order to investigate oxygen attack, the quality of feed water of boiler was measured. Figure5 shows the concentration of oxygen in boiler feed water. The results show that oxygen concentration is allowable according to Maximum allowable concentration of oxygen (7 ppb). For more investigation, some points inside steam condensate system should be measured for studying of oxygen concentration. Unfortunately, any data were recorded as daily for monitoring oxygen in the polluted steam condensate. Therefore, we cannot use experimental data for analysis. The concentration of oxygen should be sampled on site. Also the sample should be cooled for measurement. Other failure of this pipeline was reported in December 2013. Two points were failed. One point was on straight stream of pipeline and other was a tee. We were investigated morphology of corrosion after cutting of pipeline. Figure 6 shows the pitting on inner surface of straight stream of pipeline. As seen from this figure, the morphology of pitting looks likes oxygen attack. As well as, yellowish deposits demonstrate this case. Figure7 shows inner surface of tee. As seen from this figure, morphology of corrosion is similar to cavitation. As well as, this morphology in tee section was occurred and in service time, pipeline had vibration. Therefore, it is clear that cavitation phenomena have significant effect on this failure.

Figure5. Concentration of oxygen in BFW
